# Pixel Cooling Fitting Failure Studies

## 2.7/3.0 Fitting with Screen

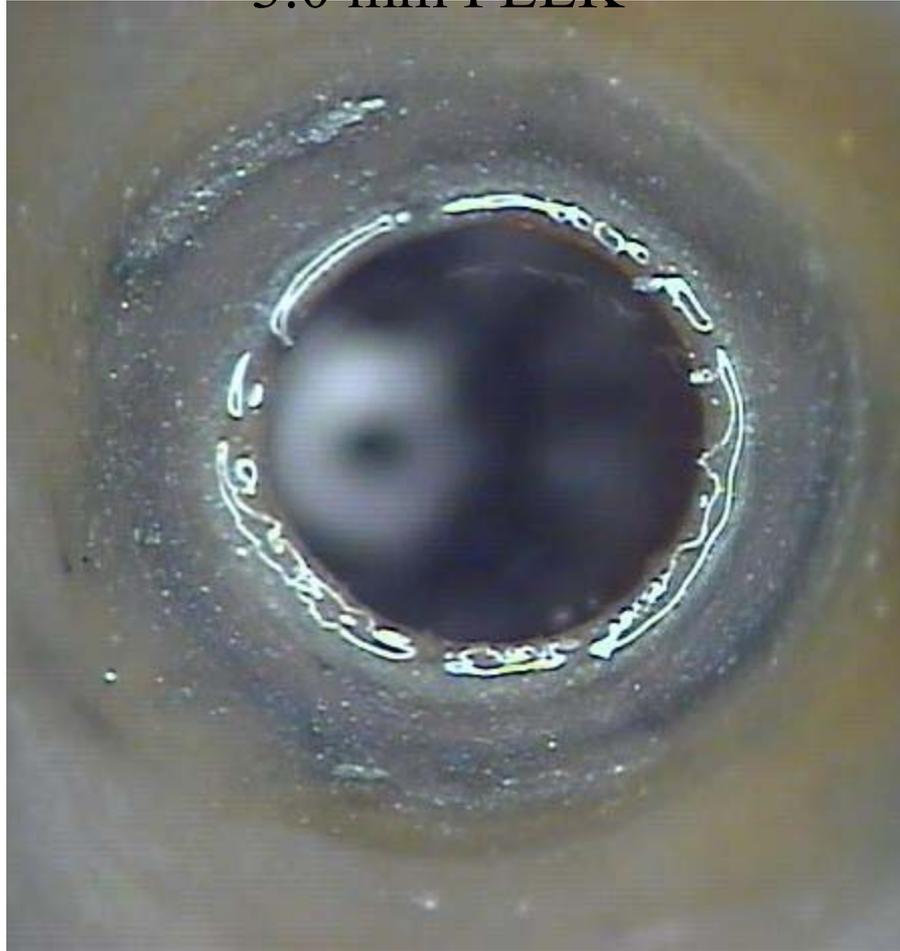
3.0 mm PEEK

- One of the 2.7mm/3.0mm sets failed the high pressure test.
- Fred and I took it apart. The 3mm flare was clearly not done properly and made minimal contact with the PEEK insert see page 3.
- The 3 flare was not flared enough and the diameter of the flare was smaller than the 2.7mm flare. See page 4. Both pictures were taken with the same magnification.
- The 2.7mm flare was not great either. Not uniformly flared.
- The next steps are the following
  - Fred will cut off the 3mm flare and re-flare it using the same tool but taking into account experience he has with recent flaring tests on samples
  - Leave 2.7mm flare as is
  - Clean all parts again, reassemble and retest, hi pressure only.
